## Smoke and Dye-Water Observation Summary

### Western Run Pilot Project - Baltimore Maryland

## INSPECTION REPORT

STREET: CLOVER RD. TEST 86 A1	MAP #1: 1	MH: 1521179
CITY: BALTIMORE	MAP #2:	MH: 1521346
LOCALE: MAIN RESIDENTIAL STREET	TAPE #: JAM 2	TV'D LGTH: 180 ft

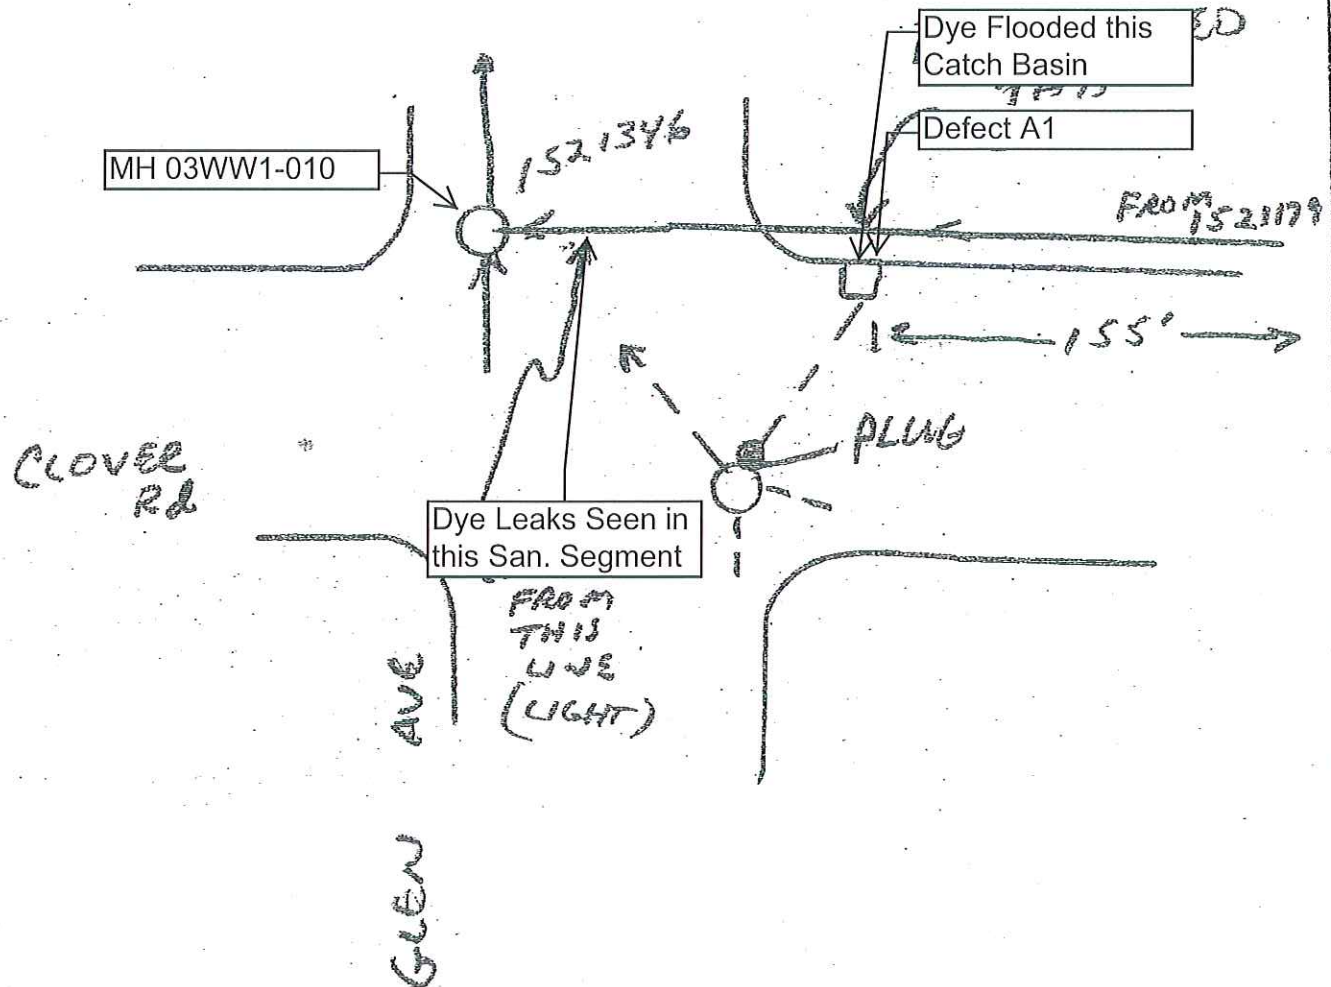
Dye Test 86

Additional Comments: THIS FLOODING (PLUG) HELD VERY WELL. THE C.B. RECEDED VERY SLOW. THE LEAK(S) ARE BE VERY SMALL. ONE SM. JOINT LEAK SEEN. (155' FROM 1521179 TO C.B. AREA.)

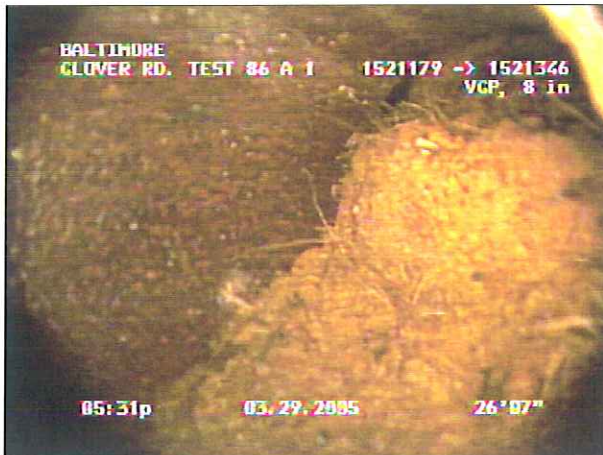
IMAGE: 17a, TAPE #: JAM 2, 00:23:06  
26.56FT, service connection with roots medium at 03 o'clock

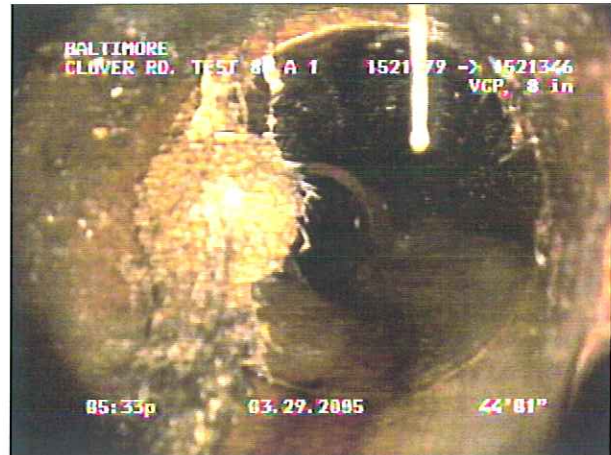
IMAGE: 18a, TAPE #: JAM 2, 00:24:12  
44.07FT, service connection with roots medium at 03 o'clock

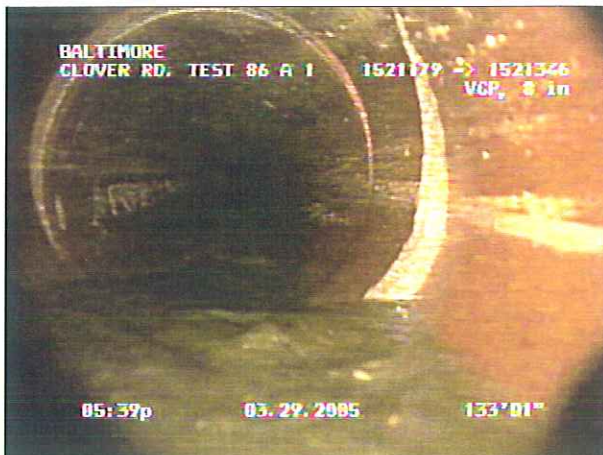
IMAGE: 22a, TAPE #: JAM 2, 00:29:36  
133.11FT, Circumferential Fracture from 12 to 12 o'clock

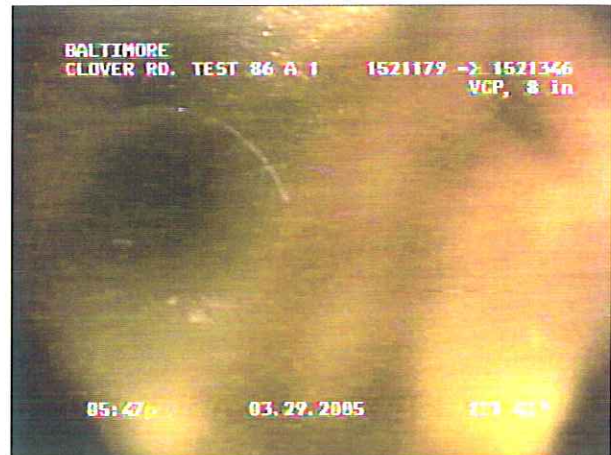
IMAGE: 23a, TAPE #: JAM 2, 00:35:49  
180FT, camera blocked, inspection abandoned, TOO MUCH DEBRIS
